Sample Report

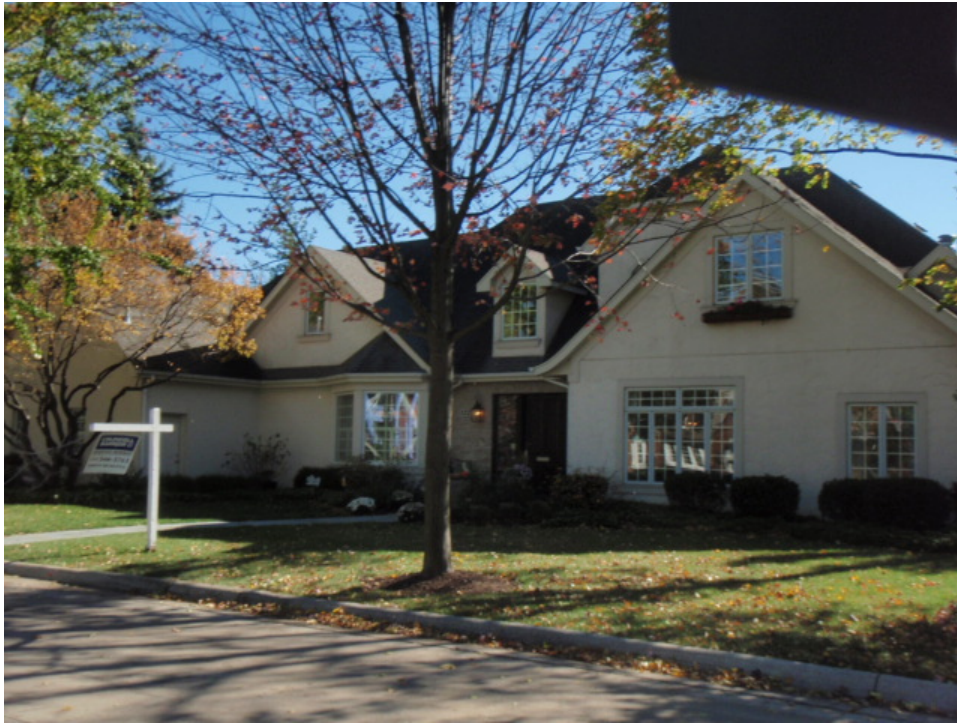
Photo 1. This is the front (north elevation).

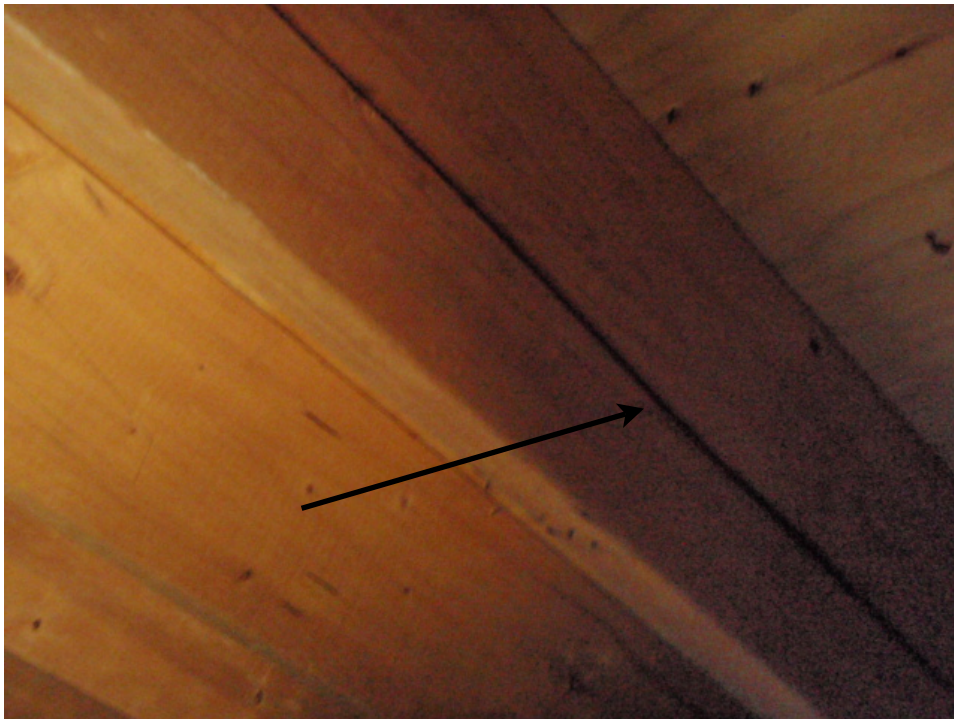
Photo 2. This is the cracked attic rafter.

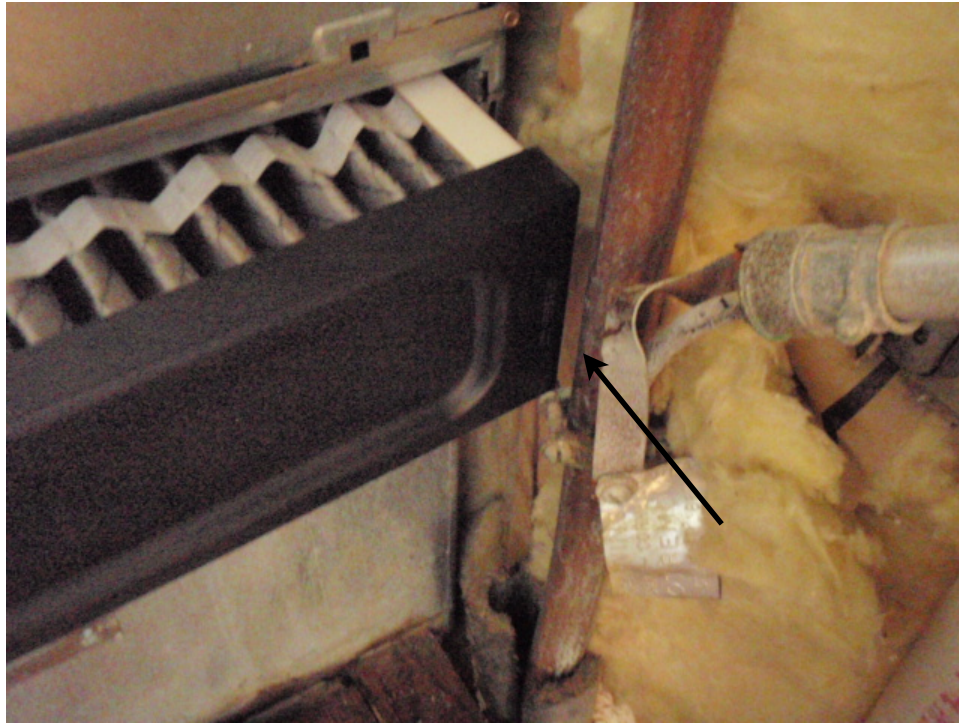
Photo 3. The main water supply pipe is blocking the furnace filter.

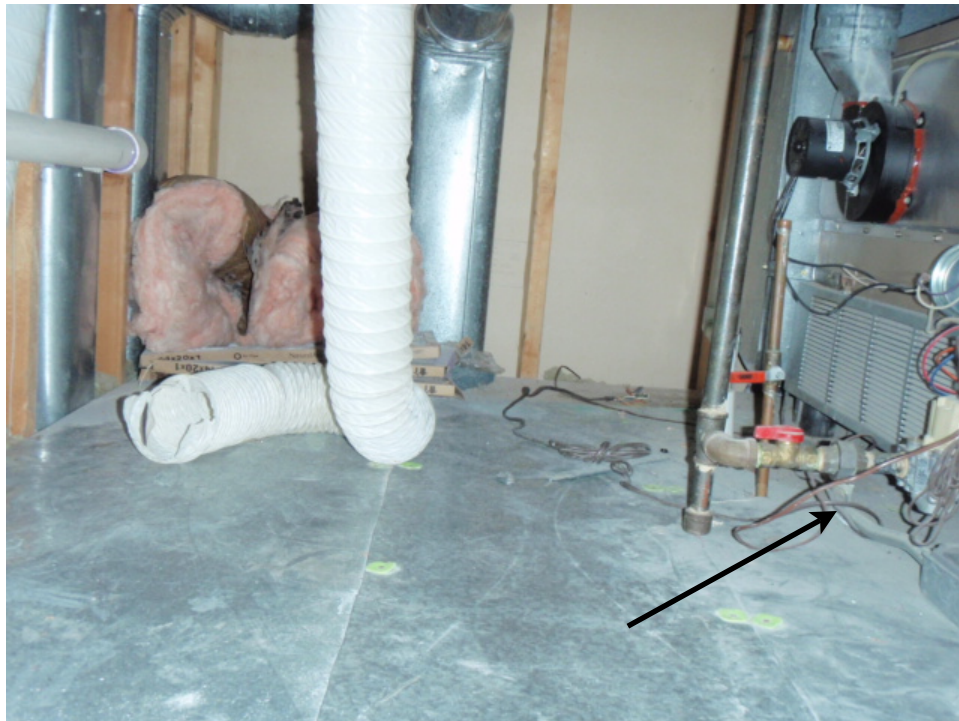
Photo 4. There is no overflow pan under the second floor furnace. *This may cause a water leak in the ceiling below.*

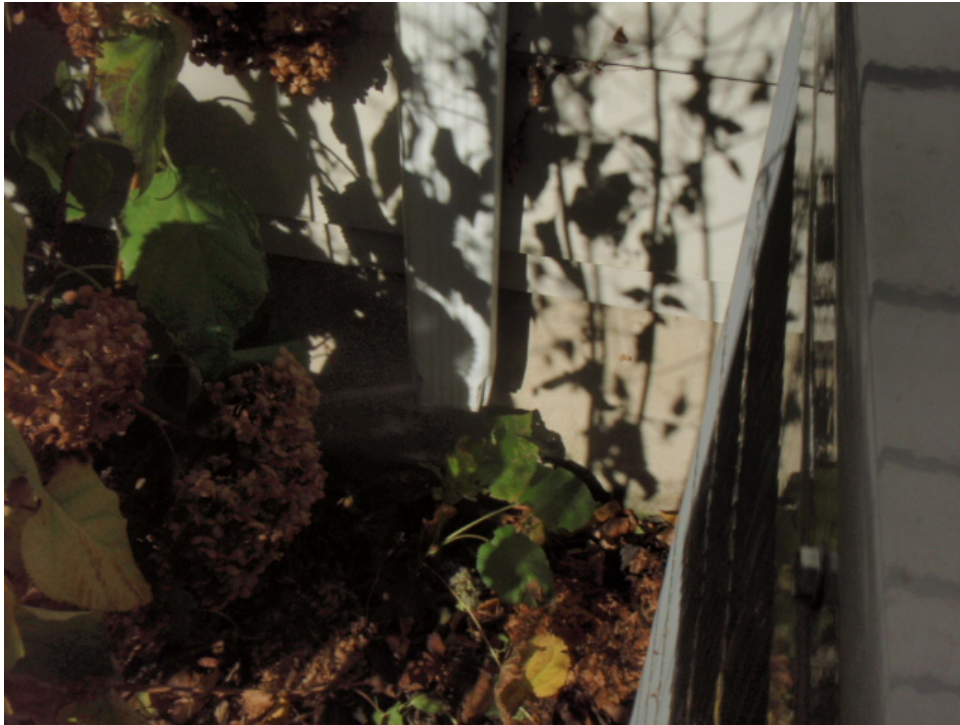
Photo 5. The downspout is disconnected and discharging alongside the foundation. *This may cause basement flooding.*

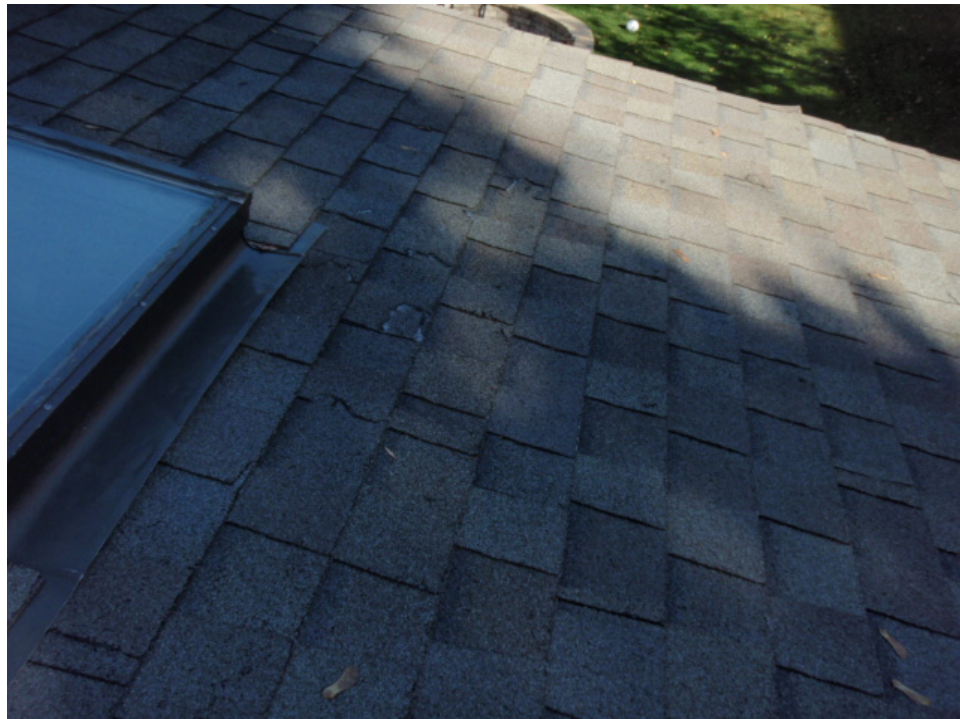
Photo 6. There are numerous worn shingles on the south elevation. *This may cause a roof leak.*
